Lacade Jurvey, Mattsmouth, Nebroska

Survey of Existing Co	nditions: Buildings (Exterior)	Survey I.D. Number:	21 & 22	
Name of Structure	Dentists - Moseman & Labart	Address:	617 & 619 Main Street

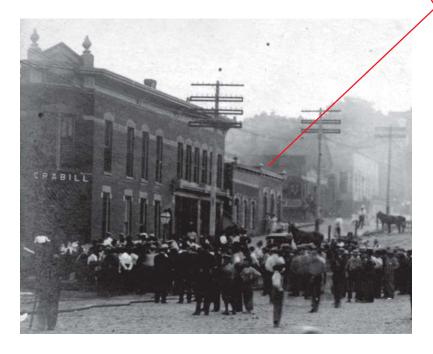
Alteration(s)	
Stylistic Feature(s)	pressed-metal hoods, cornices
Interesting Feature(s)	
Notes & Comments	619 appears in better condition than 617

Preserve pressed—metal hoods

Preserve pressed metal cornice

Restore metal finials

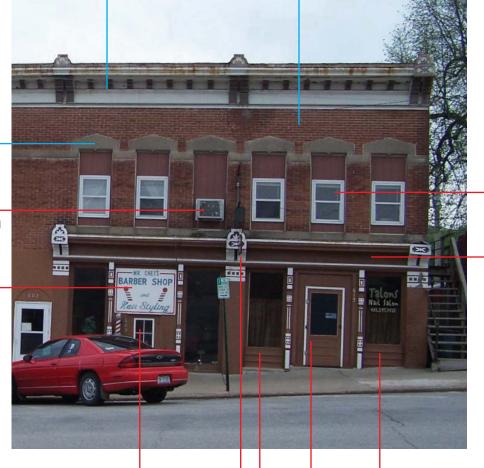
Work to	cast iron columns; pressed-metal cornice; hoods and belt course
Retain/Preserve	
Conforming Work	
Work to	cornice needs some repair; color palette could be improved
Restore/Reconstruct	
Non-Conforming	infill windows on upper floor (size and style); infill of entry door assembly; signage (style)
Work	
Notes & Comments

Preserve upper and lower pressed—metal cornices

Leave brick unpainted

Preserve stone hoods and belt course

Remove air conditioning unit from view

Select more appropriate signage

Install windows of correct size, style and material

Installation of proper awning would be appropriate

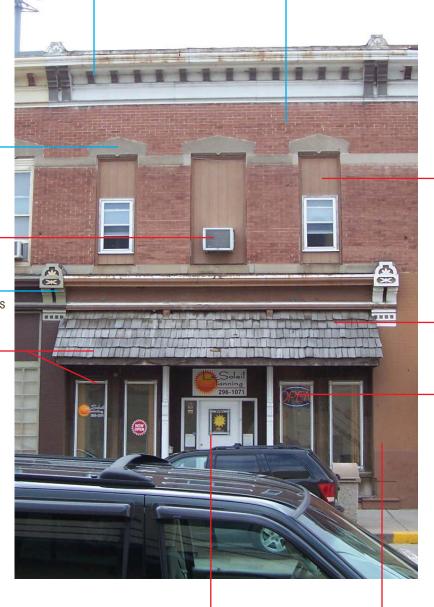
Work to	pressed-metal cornice; cast iron elements at lower facades
Retain/Preserve	
Conforming Work	
Work to	cornice needs some repair; installation of a proper awning would be appropriate
Restore/Reconstruct	
Non-Conforming	wood shake awning, inappropriate infill windows (size and material) and door assembly; visible
Work	air conditioning unit
Notes & Comments

Remove air conditioning unit from view

Restore transom windows

Install windows of correct size, style and material

Remove existing awn ing; installation of proper awning would be appropriate

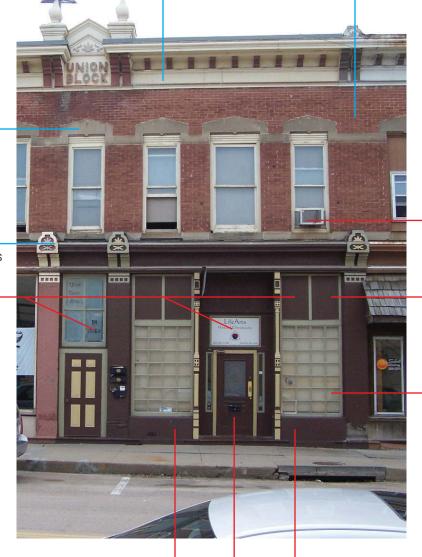
Work to	pressed-metal cornice, pediment and finials; cast iron elements; hoods and belt course
Retain/Preserve	
Conforming Work	
Work to	installation of a proper awning would be appropriate
Restore/Reconstruct	
Non-Conforming	inappropriate infill windows at lower facade (size and material); inappropriate door assembly
Work	(style and material); visible air conditioning unit; color palette
Notes & Comments

Restore transom windows

Remove air condition—ing unit from view

Installation of proper awning would be appropriate

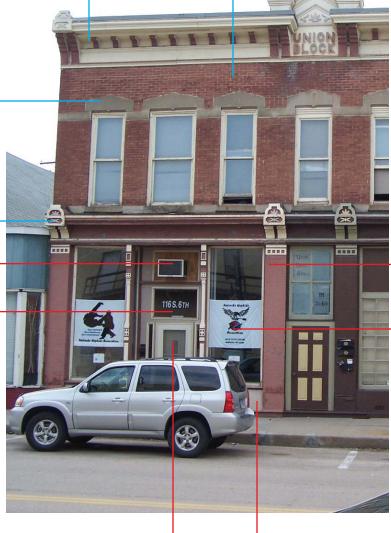
Work to	pressed-metal cornice, pediment and finials; cast iron elements; hoods and belt course
Retain/Preserve	
Conforming Work	
Work to	installation of a proper awning would be appropriate
Restore/Reconstruct	
Non-Conforming	inappropriate door assembly (style and material); visible air conditioning unit
Work	
Notes & Comments

Remove air conditioning unit from view

Restore transom windows

Installation of proper awning would be appropriate

Select more appropriate signage

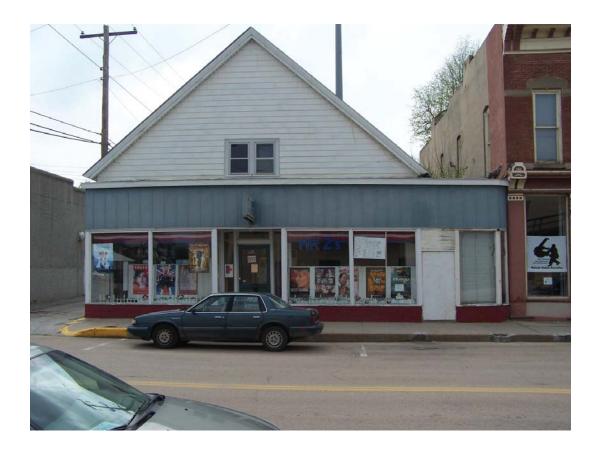
Major alterations have occured at the original First Methodist Church. It was later altered to fit the needs of a retail store. If it is the preference of the owner to remain a retail facility, the rules outlined in the "Plattsmouth Downtown Historic Guidelines" should be followed.

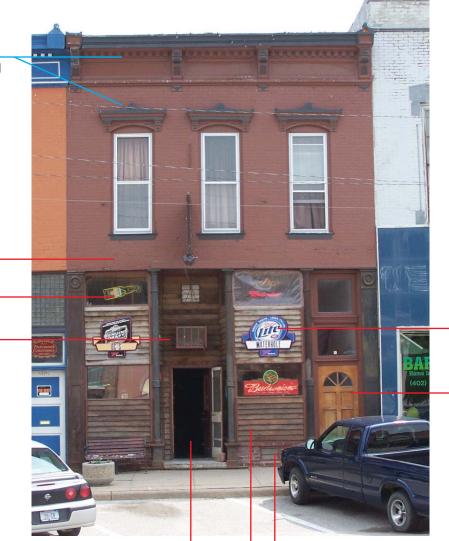
Work to	pressed-metal cornice and hoods; cast iron columns; transoms above windows
Retain/Preserve	
Conforming Work	color palette
Work to	cornice at lintel area (see historic photograph for 437 Main Street)
Restore/Reconstruct	
Non-Conforming	signage; alterations to lower façade (materials, size and style of windows and door); visible air
Work	conditioning unit
Notes & Comments

Remove air conditioning/ vent unit from view

Select more appropriate signage

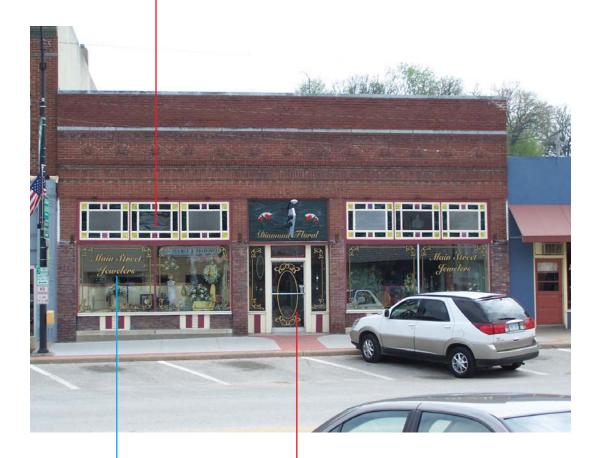
Inappropriate transom installation

Signage appropriate

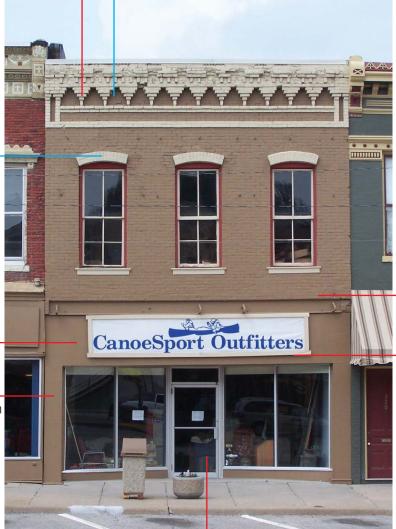
Some brick on facade in need of repair

Preserve brick cornice

Installation of proper awning would be appropriate

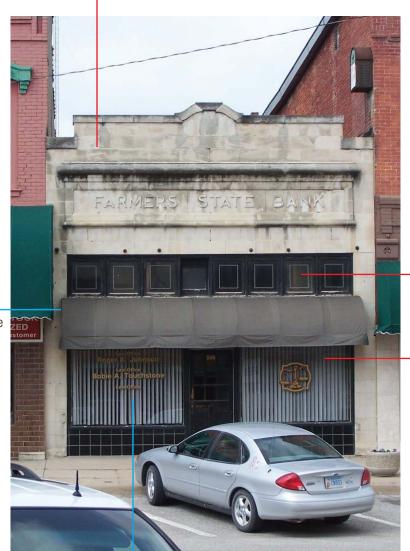
Stone in need of cleaning

Repair transoms

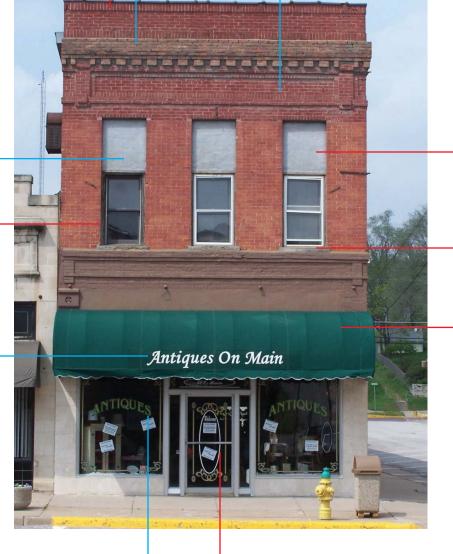
Number of Stories	2	Historic Name	Sherwood Block
Overall Shape	rectangular; three bay	NE Hist Bldg Survey	CC14-125
		No.	
Primary Wall	masonry	Historic Use	cobbler
Material(s)			
Other Material(s)	marble tile	Year(s) Built	c. 1883
Roof type	flat	Current Use(s)	shop
Windows/Doors	windows partially bricked in on	Style(s)	
	second floor; windows on east		
	façade bricked in		
		Architect/Builder	built for Robert Sherwood
Alteration(s)	some windows bricked in; modern	ized storefront; metal car	пору
Stylistic Feature(s)	brick wall cornice above storefront	t; corbelled brick cornice	on second floor; additional retail
	space along east façade;		
Interesting Feature(s)			
Notes & Comments	stone sills in need of repair

Stone sills in need of repair

Signage on awning appropriate

Install windows of correct size, style and material

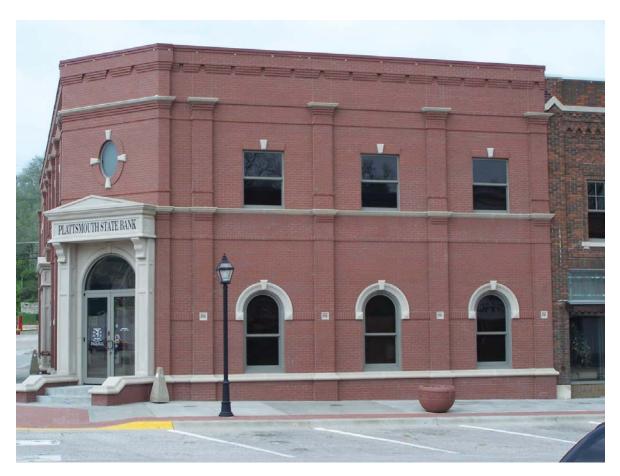
Acceptable infill building.

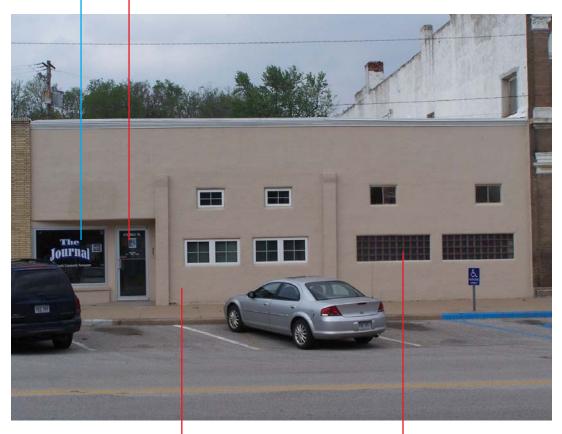
Inappropriate door

Inappropriate infill building.

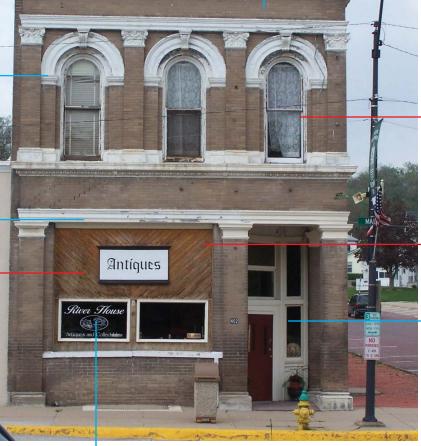
Windows in need of repair

Restore windows

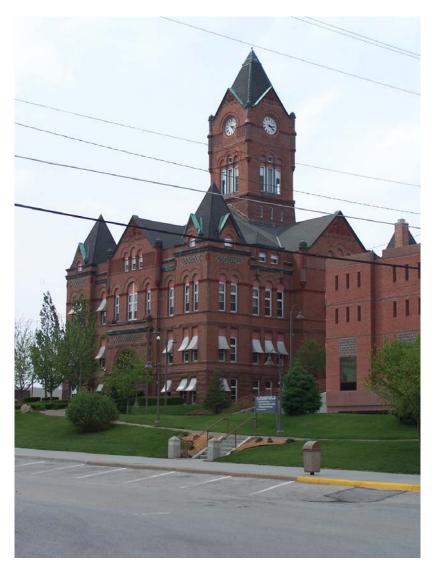
Any alterations done to the Cass County Courthouse have been historically sensitive.

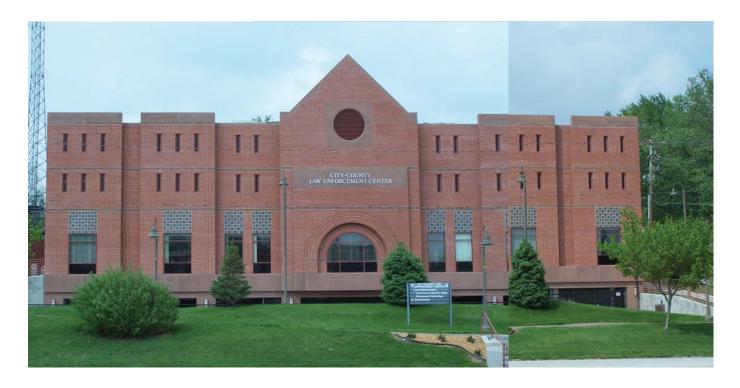
Cass County Law Enforcement Center is an acceptable addition the the Cass County complex.

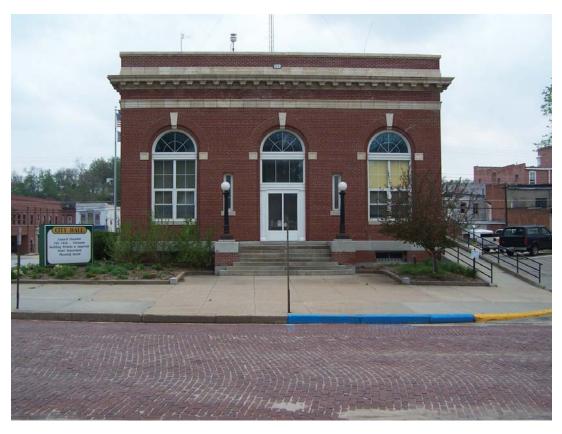
Any alterations done to the Plattsmouth City Hall have been historically sensitive.

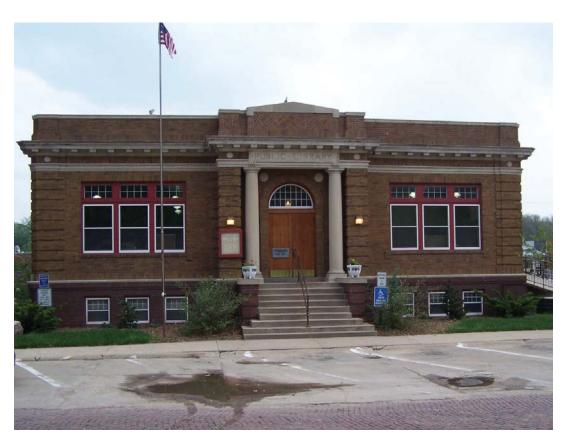
Any alterations done to the Plattsmouth Public Library have been historically sensitive.
