Lacade Jurvey, Mattsmouth, Nebroska

Survey of Existing Co	nditions: Buildings (Exterior)	Survey I.D. Number:	21 & 22	
Name of Structure	Dentists - Moseman & Labart	Address:	617 & 619 Main Street

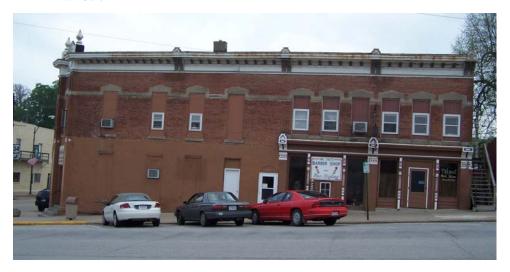
Work to	cast iron columns; pressed-metal cornice; hoods and belt course
Retain/Preserve	
Conforming Work	
Work to	cornice needs some repair; color palette could be improved
Restore/Reconstruct	
Non-Conforming	infill windows on upper floor (size and style); infill of entry door assembly; signage (style)
Work	
Notes & Comments

Preserve upper and lower pressed—metal cornices

Leave brick unpainted

Preserve stone hoods and belt course

Remove air conditioning unit from view

Select more appropriate signage

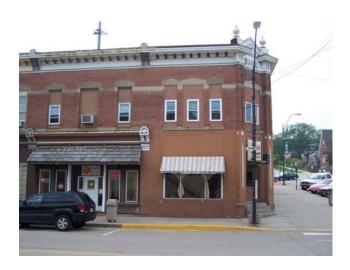
Work to	pressed-metal cornice; crown and finials; cast iron elements at lower façade; hoods and belt
Retain/Preserve	course
Conforming Work	
Work to	color palette could be improved; decorative pieces at lower windows (see historic photos);
Restore/Reconstruct	installation of proper awning on east facade
Non-Conforming	inappropriate infill windows (size and material); awning is inappropriate because window size is
Work	incorrect; entry door assembly; signage (material); replacement of lower façade is unacceptable
Notes & Comments

Installation of proper awn—ing would be appropriate

Restore original sized windows and transoms (see Fig. 1.0 in Apendix)

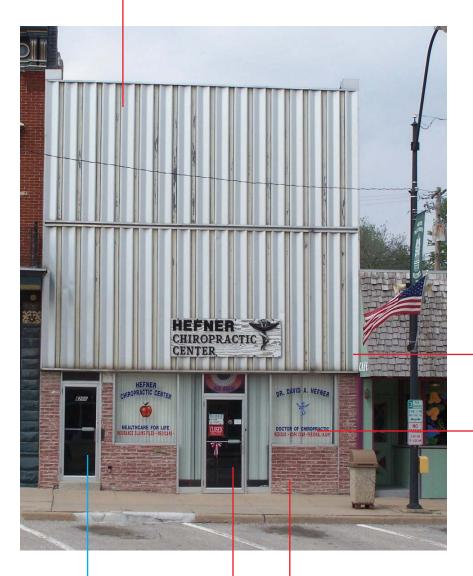
Alteration(s)	thin brick veneer, metal siding on modernized storefront
Stylistic Feature(s)	
Interesting Feature(s)	
Notes & Comments

Remove metal facade to expose possible original materials

Installation of proper awning would be appropriate

Install windows of proper size, style and material

Install new door of proper style and material

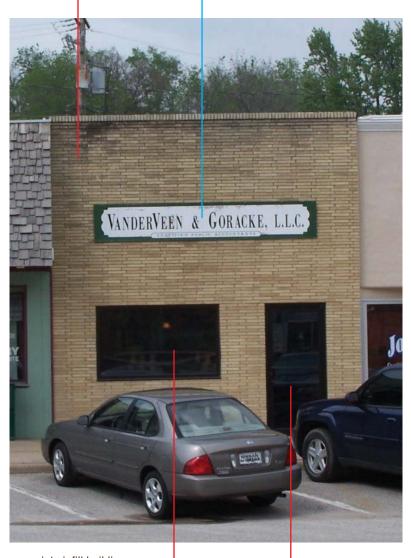
Inappropriate style of brick

Inappropriate infill building.

Inappropriate door

Inappropriate windows

Retain appropriate signage

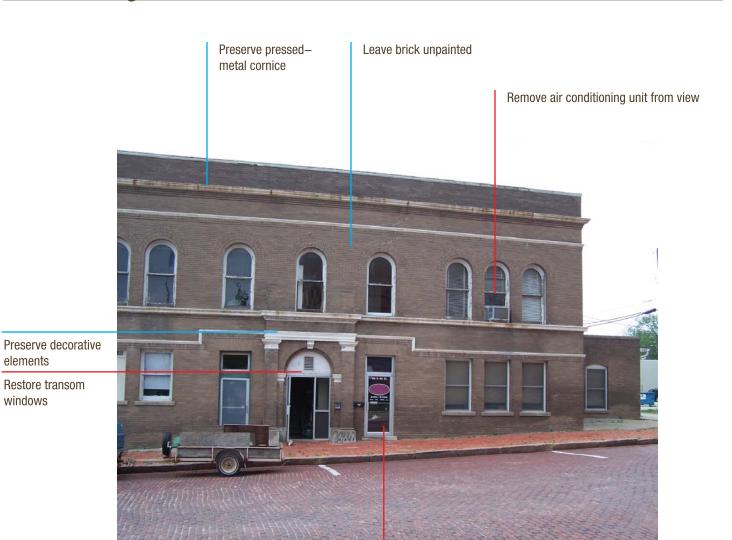
doors (material and style); visible air conditioning unit; infill of transom above main entry

Restore transom windows

Install new doors of proper style and material
